Lake Adelle Dam (MO 30411). Mississippi -
Kaskaskia - St. Louis River Basin.
Jefferson County, Missouri. Phase I
Inspection Report.

SUBJECT: Lake Adelle Dam Phase I Inspection Report
Jefferson County, Missouri
Missouri Inventory No. 30411

LAKE ADELLE DAM
JEFFERSON COUNTY, MISSOURI
MISSOURI INVENTORY NO. 30411

PHASE I INSPECTION REPORT
NATIONAL DAM SAFETY PROGRAM

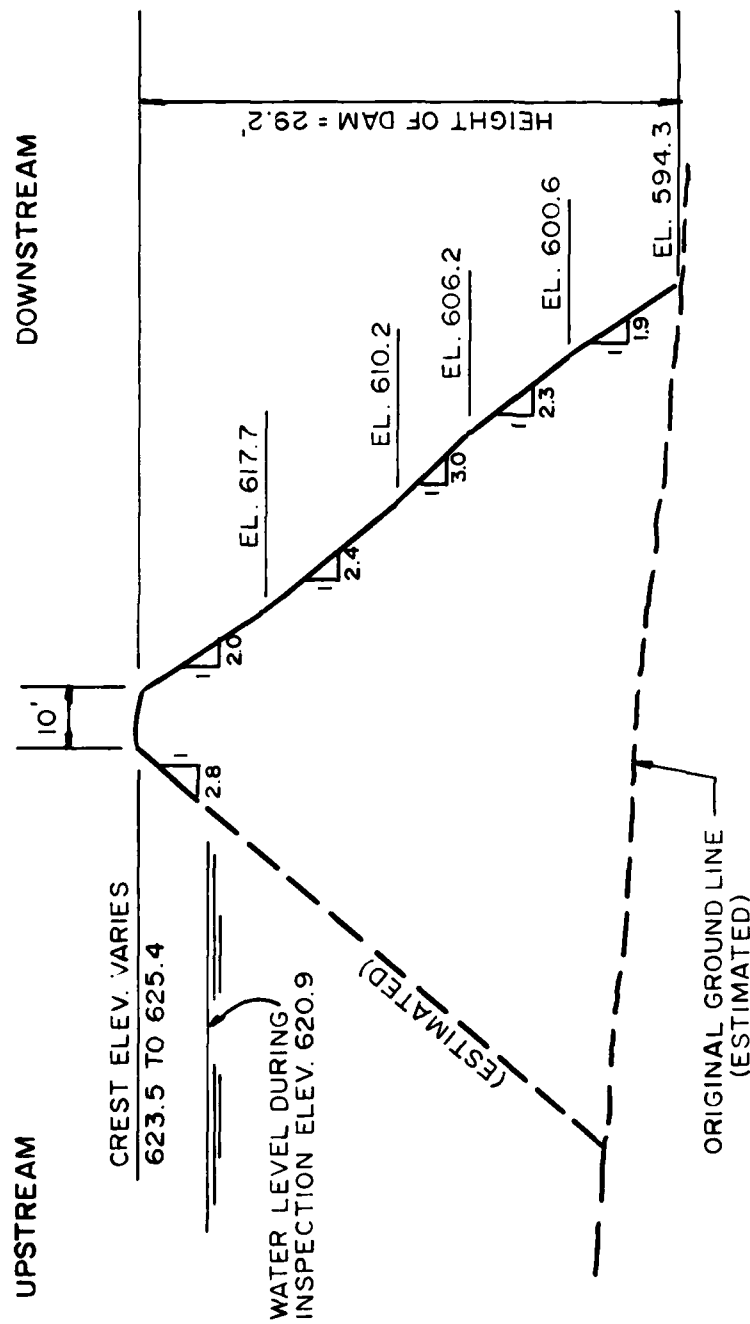
TYPICAL CROSS SECTION OF DAM

The downstream face of the dam had a slope which varied from about 1.9 horizontal to 1 vertical to about 3.0 horizontal to 1 vertical and also had a rather irregular surface. A typical cross section of the dam can be seen on Plate 5 of Appendix A. The downstream face of the dam was generally irregular. The exact cause for the variation in slope and the surface irregularity could not be determined but did not appear to be the result of sloughing and was probably the result of the original construction and some erosion. The variation in slope and the surface irregularity did not appear to be related to the variations in the dam crest elevations. The downstream face had a heavy brush cover and had several trees on it. There were several piles of brush and branches as a result of clearing which was reported to have taken place in the previous year. The heavy brush inhibited a thorough inspection of the downstream face. Two views of the downstream face are given on Photographs 4 and 5.
